GEOLOGIC AND GEOTECHNICAL FEASIBILITY EVALUATION

APN 2724-004

SAN FRANCISCO, CALIFORNIA

Project No. 6088-1

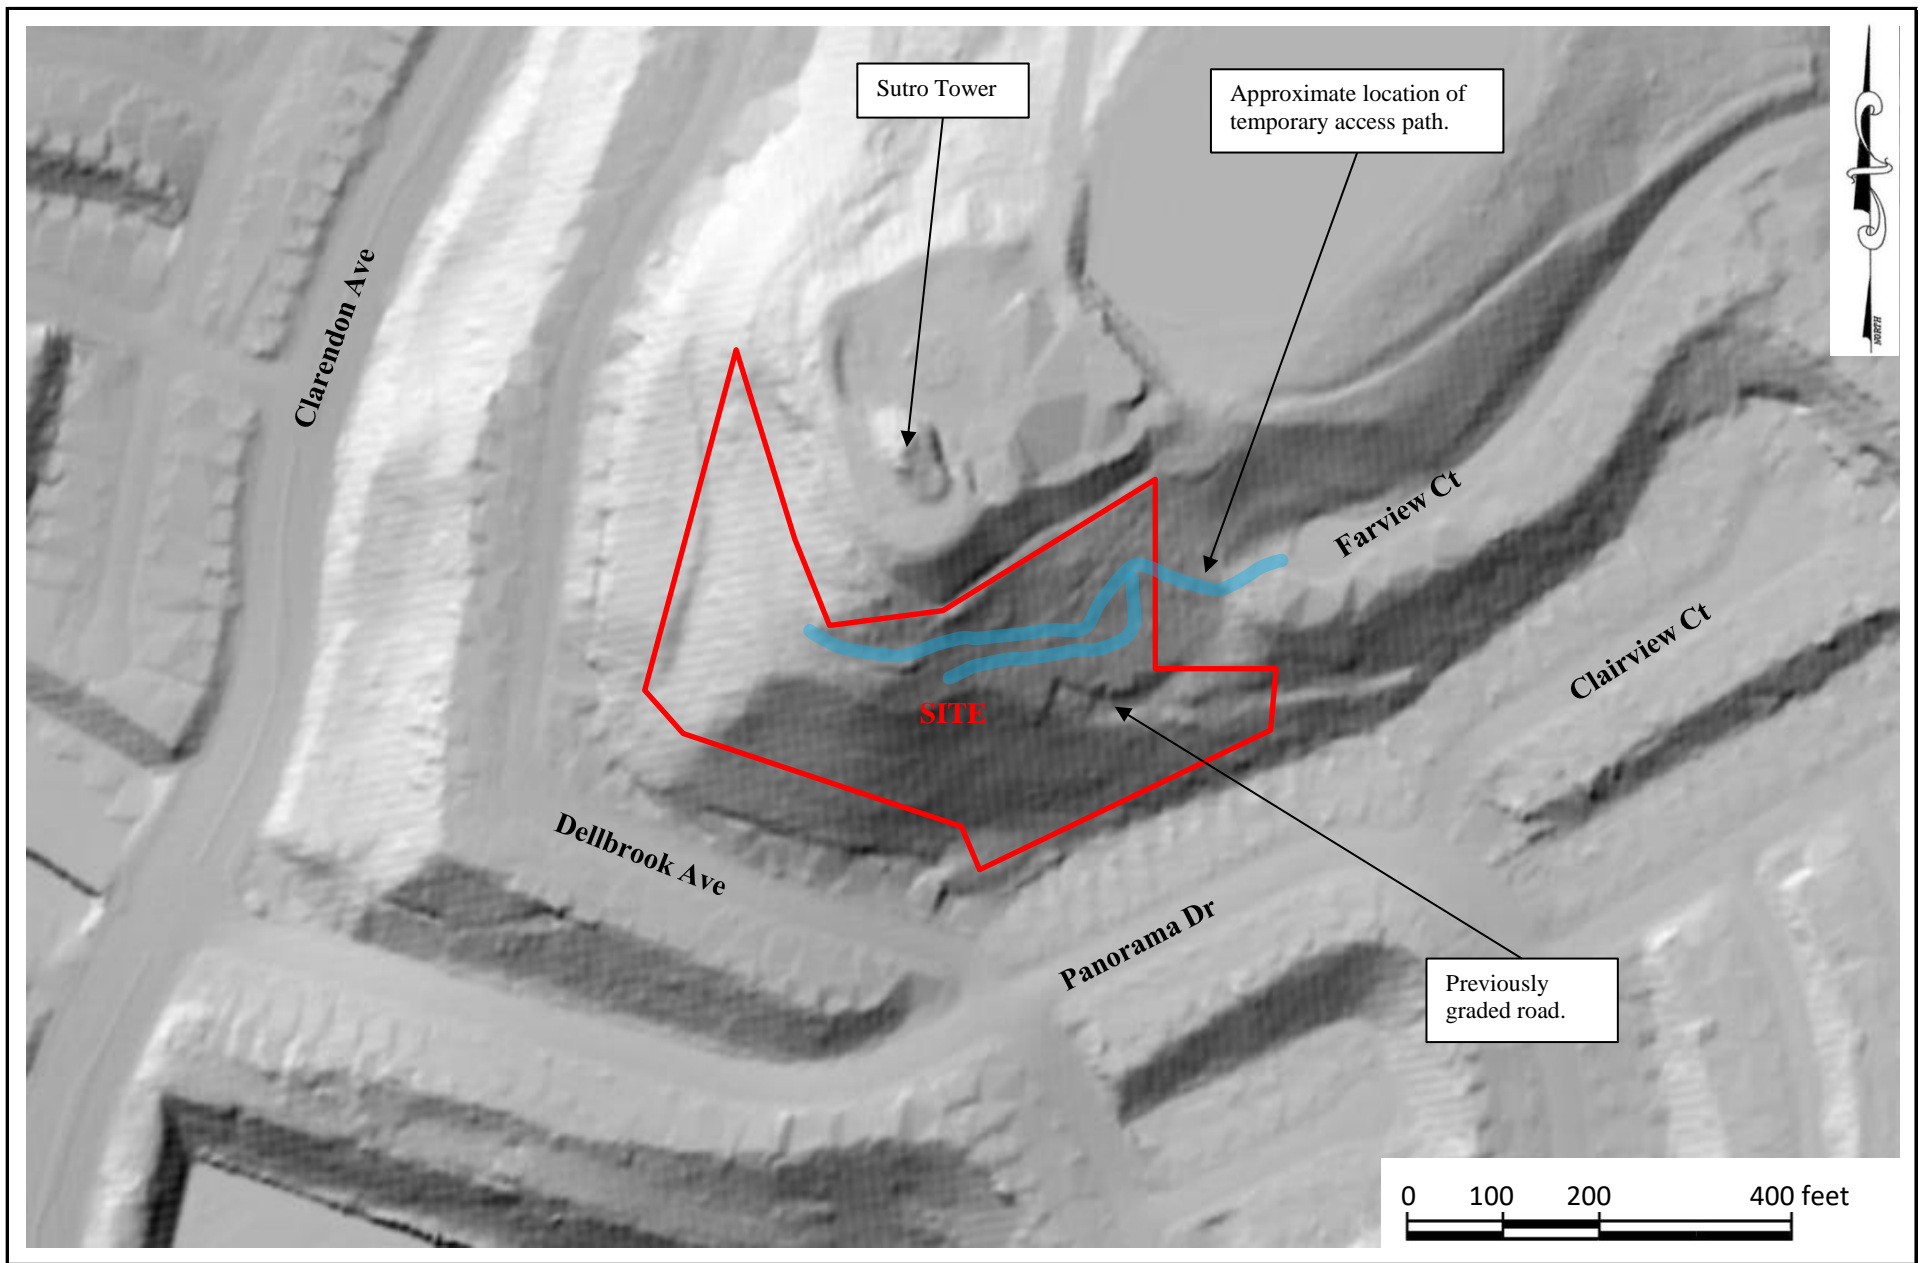
FIGURE 4
NOVEMBER 2022
PROJECT NO. 6088-1

Oversteepened slopes of limited lateral extent are shown on Figure 2 topography and are apparent on Figure 4. These occurrences appear to be primarily related to the previously noted rough-graded path, and are not the result of landsliding. Elsewhere, variability in slope inclinations are likely due to differential weathering of the underlying bedrock.

We noted a “nose” or topographic feature on the cut slope, as indicated on Figure 2. This feature did not appear on aerial photographs or the LIDAR imagery (Figure 4), and we

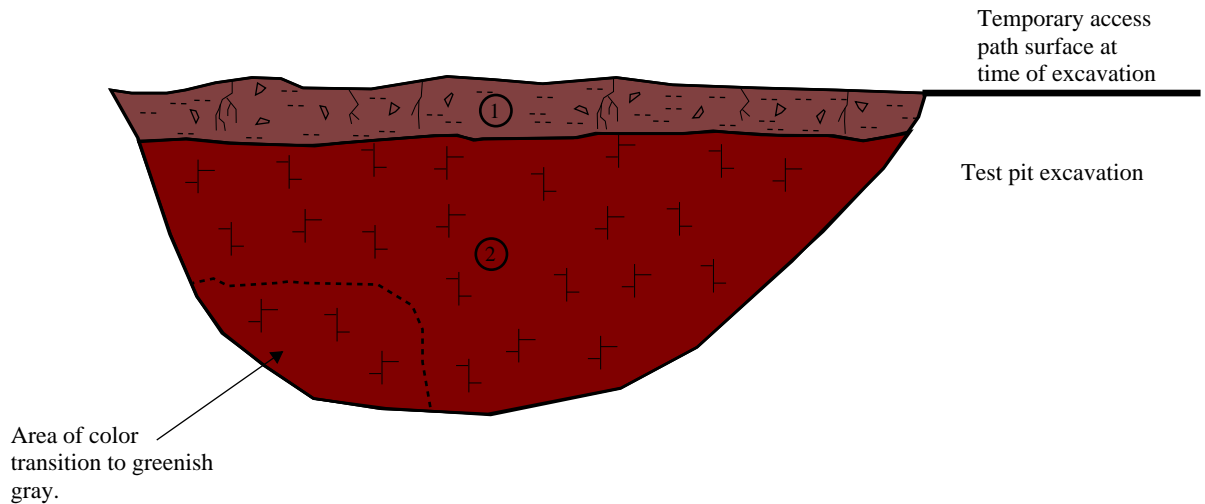
At the location of Test Pit TPU-1, which was excavated on the west end of the upper temporary access path, we generally encountered approximately 1 to 1.5 feet of colluvium. The colluvium was composed of sandy lean clay of moderate plasticity and contained abundant roots and primarily chert rock fragments. The colluvium was underlain by chert bedrock of the Franciscan Complex. The bedrock was intensely weathered, fractured, and massive, with no discernable bedding orientation visible in the test pit. Note that although the chert exposed in Test Pit TPU-1 was massive, a nearby ground surface chert outcrop, approximately 30 to 40 feet upslope, was bedded with a strike of approximately east-west and dip (inclination) of 32 degrees north.

1. Colluvium (CL): Dark brown to dark reddish brown, Sandy Lean Clay, moist, moderate plasticity, angular rock fragments up to 4 inches in width, abundant roots.

2. Franciscan Complex (BR): Reddish brown and greenish gray, chert, moist, intensely weathered, fractured, massive, manganese oxide staining on fractures.

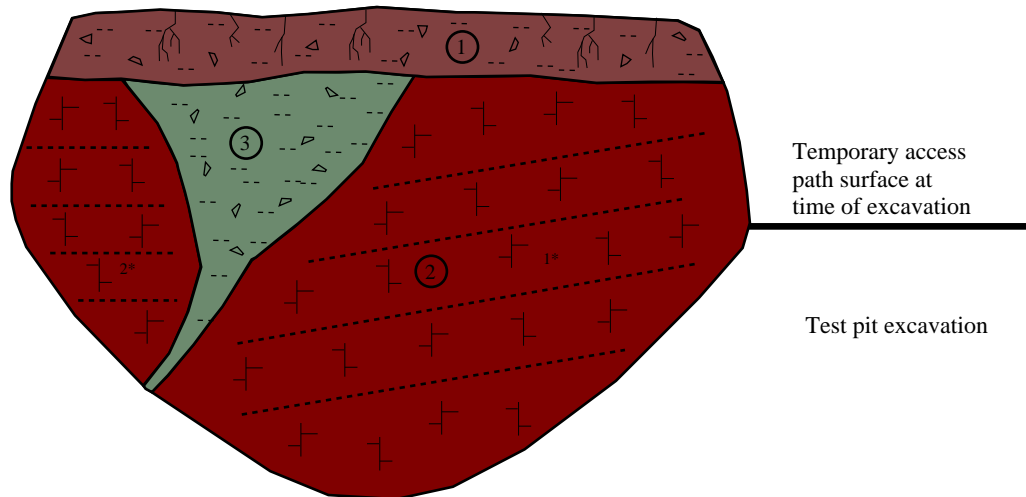
TPU-3

At the location of Test Pit TPU-3, which was excavated near the center of the upper temporary access path, we generally encountered approximately 1.5 to 2 feet of colluvium. The colluvium was composed of sandy lean clay of moderate plasticity and contained abundant roots and primarily chert rock fragments. The colluvium was underlain by thinly bedded chert bedrock of the Franciscan Complex. We observed a possible shear zone or infill feature within the chert bedrock. This feature was a different color from the host bedrock and was primarily composed of small rock fragments within a clayey matrix. Sheared rocks within the Franciscan Complex are common and are associated with tectonic events which occurred millions of years in the past, and are thus not of present concern.

1. Colluvium (CL): Dark brown to dark reddish brown, Sandy Lean Clay, moist, moderate plasticity, angular rock fragments up to 4 inches in width, abundant roots. .

2. Franciscan Complex (BR): Reddish brown and greenish gray, chert, moist, intensely weathered, fractured, massive, manganese oxide staining on fractures.

3. Possible Shear Zone: Greenish gray to white, orange-red clayey matrix with small rock fragments, moist, intensely weathered. Possibly secondary infill.

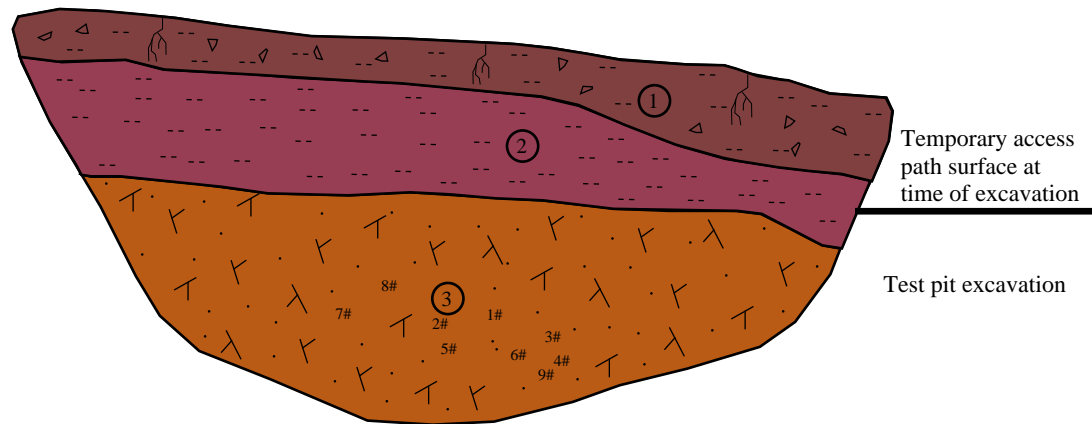
TPU-4

At the location of Test Pit TPU-4, which was excavated near the center of the upper temporary access path, we generally encountered approximately 1 to 2 feet of colluvium. The colluvium was composed of sandy lean clay of moderate plasticity and contained abundant roots and primarily chert rock fragments. The colluvium was underlain by a lighter colored residual soil comprised of a sandy lean clay with a relict rock fabric/texture. The residual soil was underlain by sandstone bedrock of the Franciscan Complex. The rock was massive with no observable bedding, and heavily fractured along three observed fracture set orientations.

1. Colluvium (CL): Dark brown to dark reddish brown, Sandy Lean Clay, moist, moderate plasticity, abundant roots.

2. Residual Soil (CL): Yellowish tan, Sandy Lean Clay, fine to medium grained, strong relict rock texture, roots.

3. Franciscan Complex (BR): Yellowish tan, Sandstone, moist, very severely weathered, fractured, massive, reddish brown to dark brown oxidation staining, 3 fracture planes observed and measured.

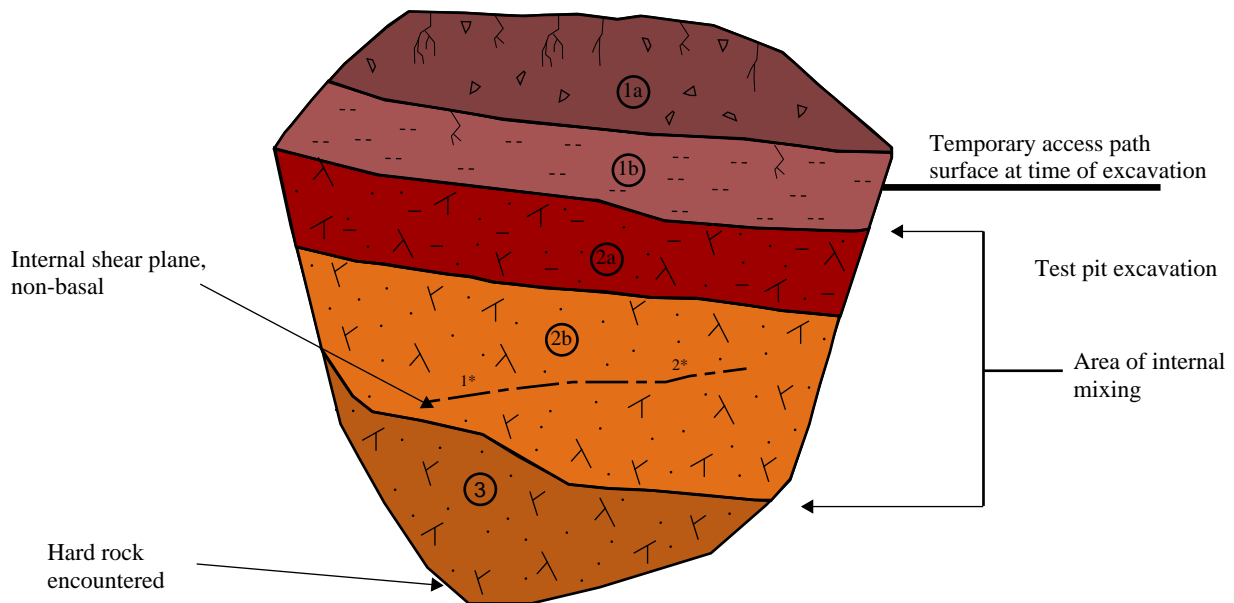
We observed several locations with potential slide/shear planes that dip along the direction of the slope, specifically in test pits TPU-5 within the sandstone bedrock and TPL-3, juxtaposing soil and sandstone bedrock. Although only vaguely visually apparent as surficial features, our TPU-5 and TPL-3 observations of thickened soil and downslope-oriented shear planes indicate the likelihood of past shallow landsliding which may (especially at the location of TPU-5 included the shallow bedrock, as approximated on Figure 2.

1a. Colluvium (CL): Dark brown to dark reddish brown, Sandy Lean Clay, moist, moderate plasticity, angular rock fragments up to 4 inches in width, abundant roots.

1b. Colluvium (CL): Dark brown to dark reddish brown, Sandy Lean Clay, moist, moderate plasticity, few rock fragments, few roots.

2b. Franciscan Complex (BR): Primarily dark grayish brown to dark reddish brown, Sandstone, moist, intensely weathered Shale/claystone interbeds, mixed, disseminated manganese oxide staining.

3. Franciscan Complex (BR): Yellowish tan, Sandstone, moist, very severely weathered, massive, fine grained.

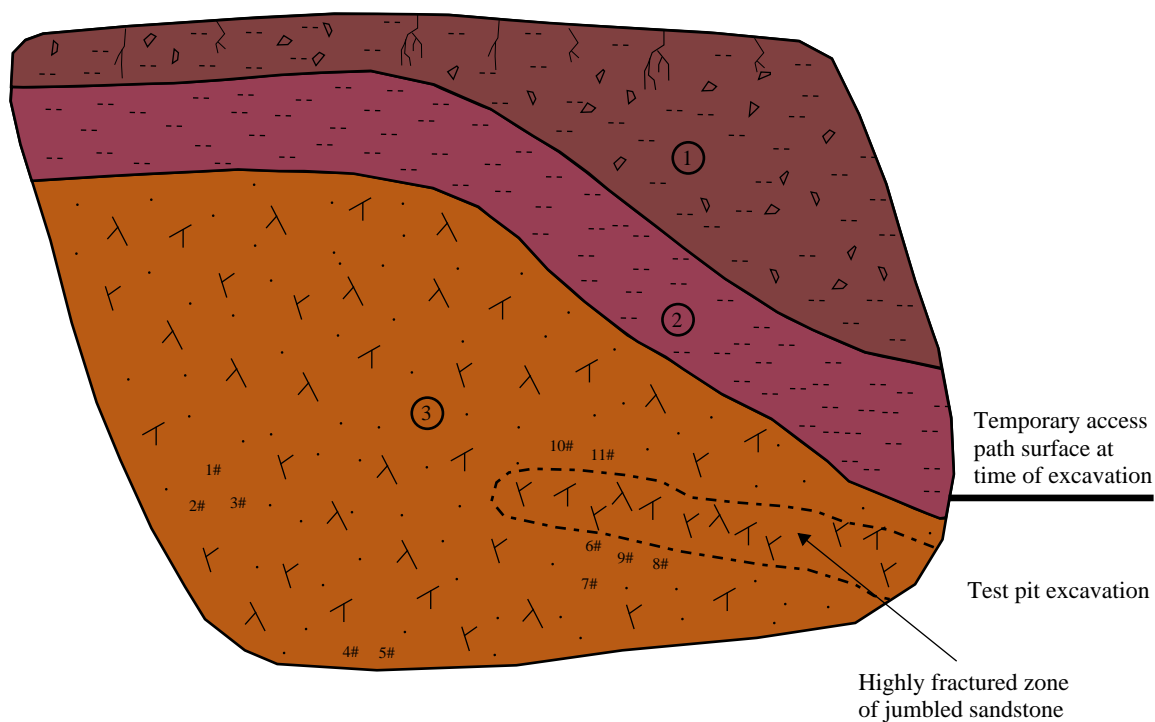
TPL-2

At the location of Test Pit TPL-2, which was excavated east of Test Pit TPL-1 on the lower temporary access path, we generally encountered approximately 2 to 2.5 feet of colluvium. The colluvium was composed of sandy lean clay of moderate plasticity and contained roots and primarily chert rock fragments. The colluvium was underlain by residual soil composed of sandy lean clay with an apparent strong relict rock fabric/texture. The residual soil was underlain by sandstone bedrock of the Franciscan Complex. The rock was massive, fractured, and included chert and shale. We obtained multiple fracture orientations however clear fracture sets were not apparent. We also observed a 1 to 2 foot thick zone of highly fractured and jumbled sandstone within the larger rock unit.

1. Colluvium (CL): Dark brown to dark reddish brown, Sandy Lean Clay, moist, moderate plasticity, angular rock fragments, roots.

2. Residual Soil (CL): Tan brown to light reddish brown, Sandy Lean Clay, fine to medium grained, strong relict rock texture, roots, grained sand.

3. Franciscan Complex (BR): Grayish tan to reddish brown, Sandstone, fractured, massive, fine grained, manganese oxide staining, includes chert and shale, generally hard.

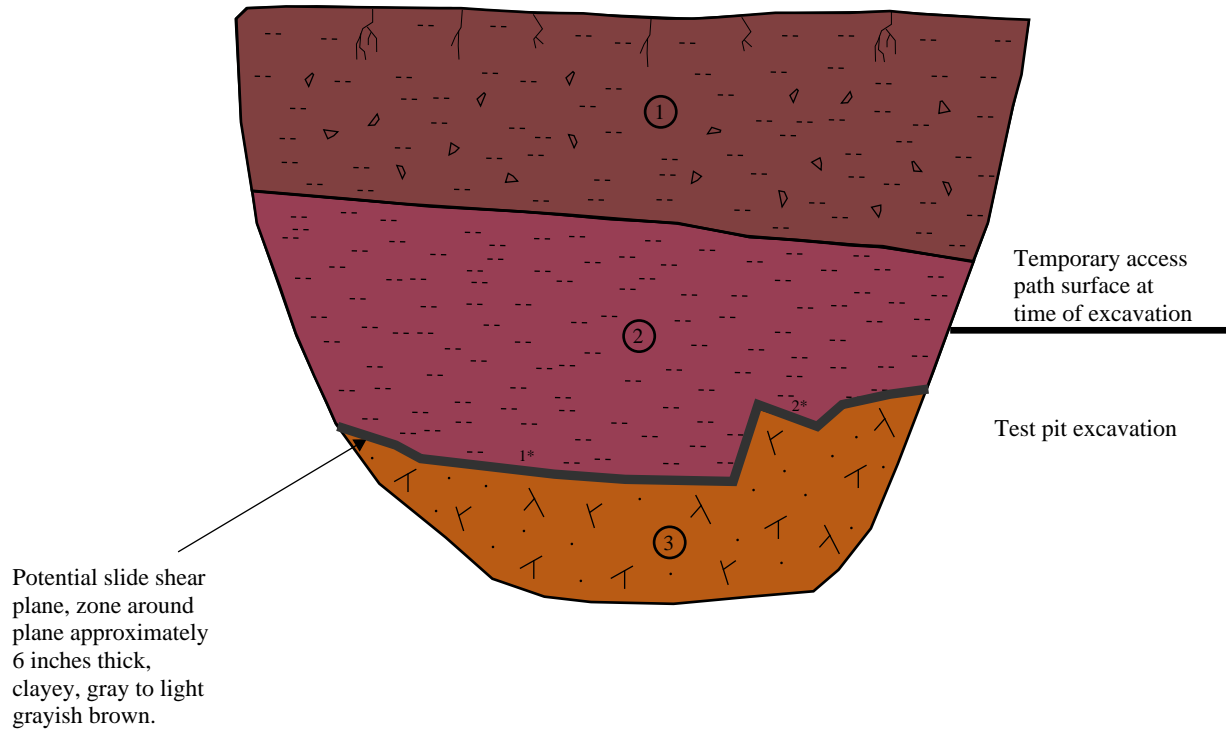
TPL-3

1. Colluvium (CL): Dark brown to dark reddish brown, Sandy Lean Clay, moist, moderate plasticity, angular rock fragments, roots.

2. Residual Soil (CL): Dark reddish brown, Sandy Lean Clay, moist, fine to medium grained, strong relict rock texture, rock sandstone fragments.

3. Franciscan Complex (BR): Yellowish tan, Sandstone, moist, very severely weathered, friable, massive, soft.

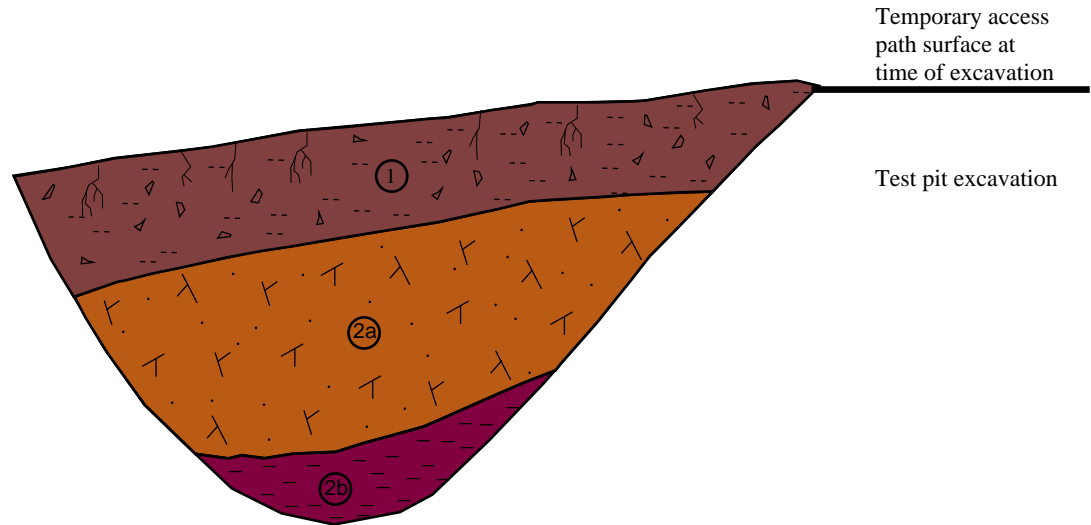
TPL-4

At the location of Test Pit TPL-4, which was excavated at the east end of the lower temporary access path, we generally encountered approximately 3 to 3.5 feet of colluvium. The colluvium was composed of sandy lean clay of moderate plasticity and contained roots and primarily chert rock fragments. The colluvium was underlain by 5 feet of sandstone bedrock of the Franciscan Complex followed by a transition to claystone and siltstone bedrock. The bedrock was very severely weathered, massive, with no clear fracture or bedding orientations.

1. Colluvium (CL): Dark brown to dark reddish brown, Sandy Lean Clay, moist, moderate plasticity, angular chert fragments, roots.

2a. Franciscan Complex (BR): Reddish brown to tan brown, Sandstone, moist, very severely weathered, fine grained, massive, red to black oxidation staining, no preferred fracture orientation, soft.

2b. Franciscan Complex (BR): Reddish brown to tan brown, Claystone and Siltstone, moist, very severely weathered, massive, red to black oxidation staining, no preferred fracture orientation, soft.
