GEOLOGIC AND GEOTECHNICAL FEASIBILITY EVALUATION

APN 2724-004

SAN FRANCISCO, CALIFORNIA

Project No. 6088-1

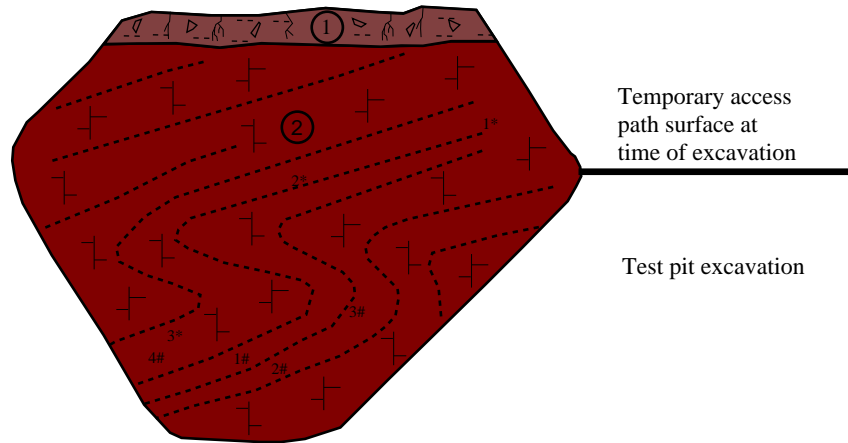
TPU-2

1. Colluvium (CL): Dark brown to dark reddish brown, Sandy Lean Clay, moist, moderate plasticity, angular rock fragments up to 4 inches in width, abundant roots.

2. Franciscan Complex (BR): Dark reddish brown to grayish black, Chert, moist, very severely weathered, fractured, folded, red-brown clay development between beds.

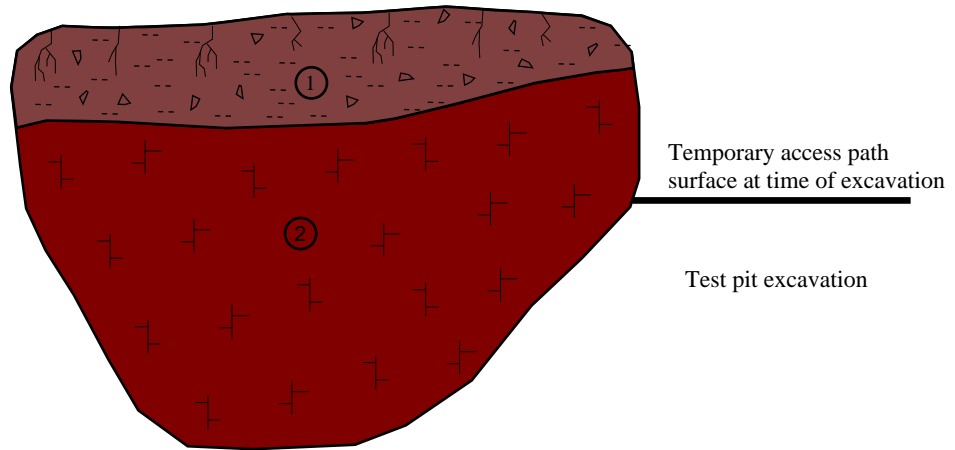
TPU-6

1. Colluvium (CL): Dark brown to dark reddish brown, Sandy Lean Clay, moist, moderate plasticity, angular fragments up to 4 inches in width, abundant roots.

2. Franciscan Complex (BR): Reddish brown and greenish gray, chert, moist, intensely weathered, irregular bedding, intensely sheared, intensely weathered pockets of clay throughout, massive, abundant polished manganese oxide staining, minor quartz? deposition.

Note: Fracture spacing <1" to 6", variably oriented.
